MATERIEX CASE STUDY
LEAKAGE IN RADIATOR FITTINGS

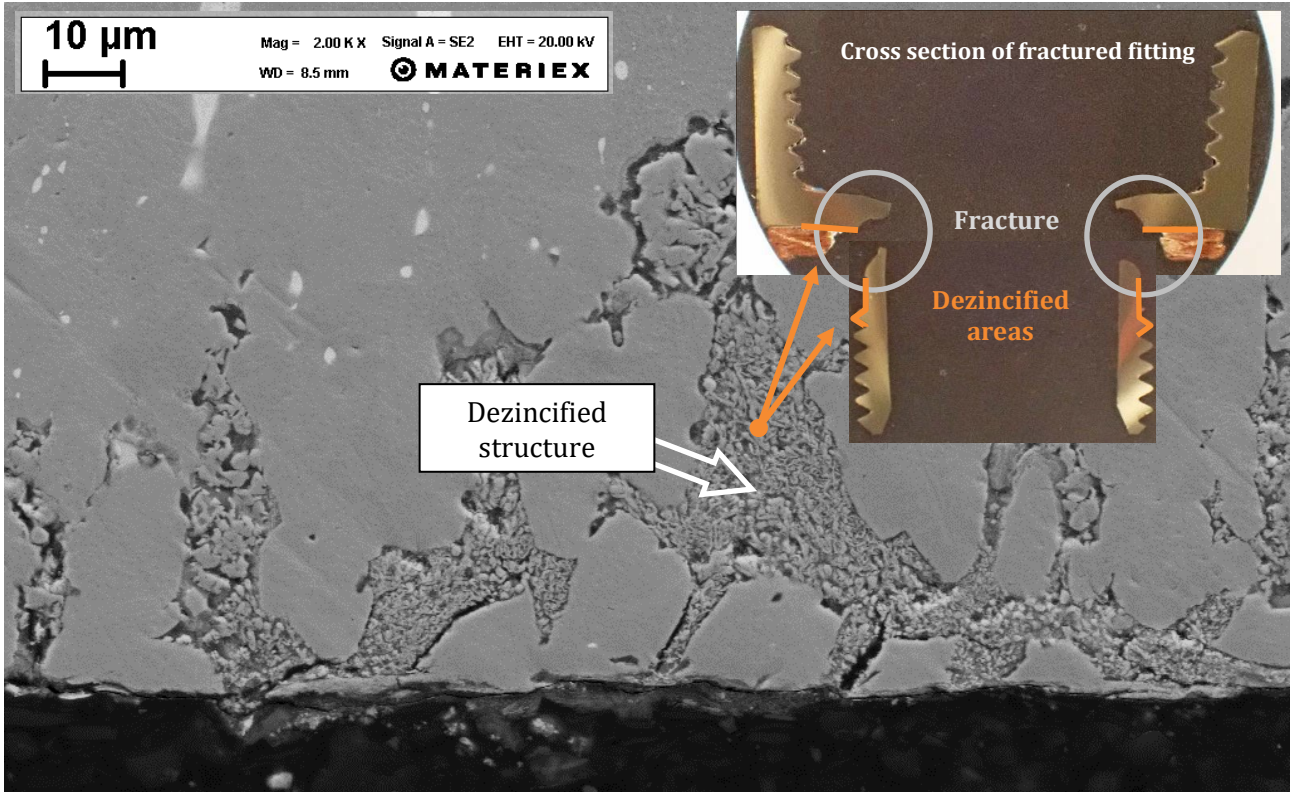
- The leakage had occurred due to cracking initiated at the sharp corner on the outside of the fitting (Figure 1). Smaller cracks (100 µm) were also observed in the same corner of the non-leaking fitting (Figure 2).
- Investigation in SEM showed that the crack initiation sites were dezincified (Figure 1 and Figure 2). Dezincification is a corrosion process that selectively removes zinc from the brass alloy (if Zn>15%), leaving a porous copper-rich structure with reduced mechanical strength.
- The chemical composition of the fittings was identified as brass CW608N (60% Cu, 38% Zn, 2% Pb).
- The mode of fracture near the crack tip was identified as ductile (Figure 3). As the mechanical strength has been reduced by the dezincification process, the torque used during re-tightening after the thermostat change has probably been sufficient to initiate cracking.

Figure 1. Dezincified surface close to the crack initiation of the leaking fitting (SEM).

The leakage was caused by dezincification resulting in a reduced mechanical strength, subsequently making the fittings more prone to cracking. The leakage could have been prevented by using fittings in dezincification-resistant brass instead of reusing 40-year-old fittings of an alloy that is typically not resistant to corrosive mediums that might be used in the specific environment. Brass is particularly sensitive to ammonia, which is found in some all-purpose cleaning products.

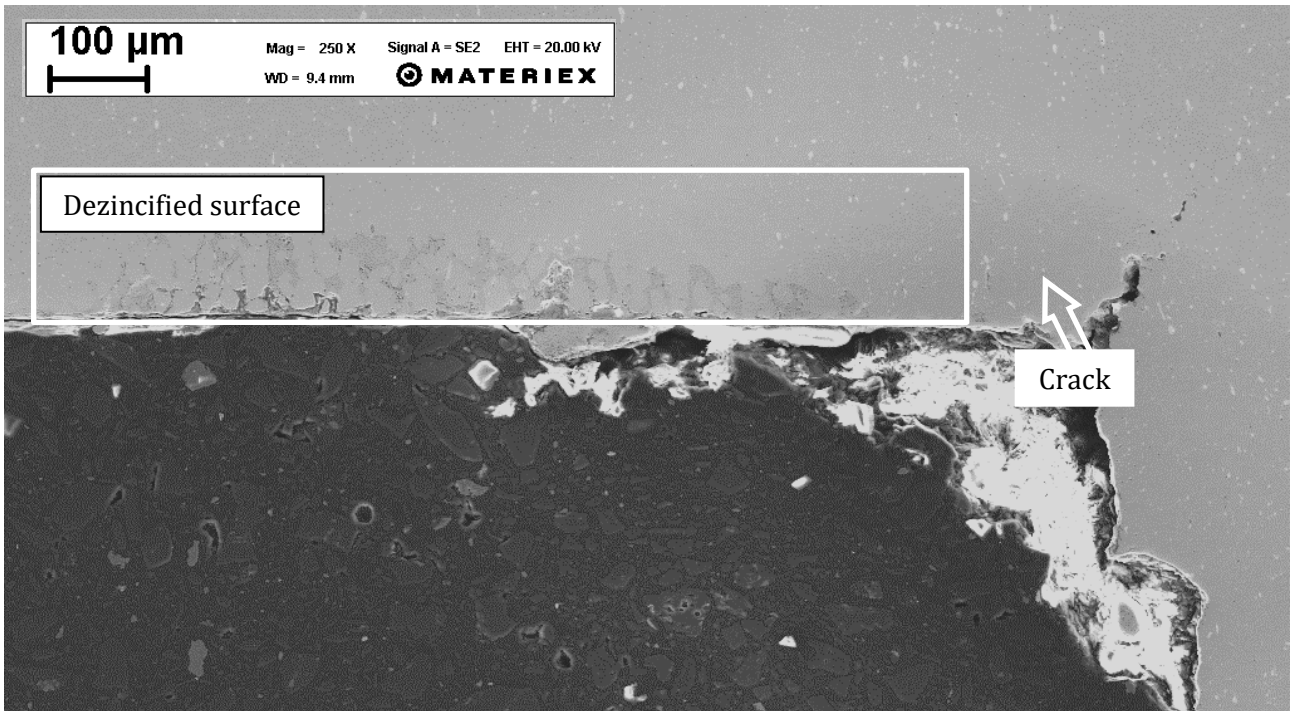
Figure 2. Dezincified surface and cracking in part A of non-leaking fitting (SEM).

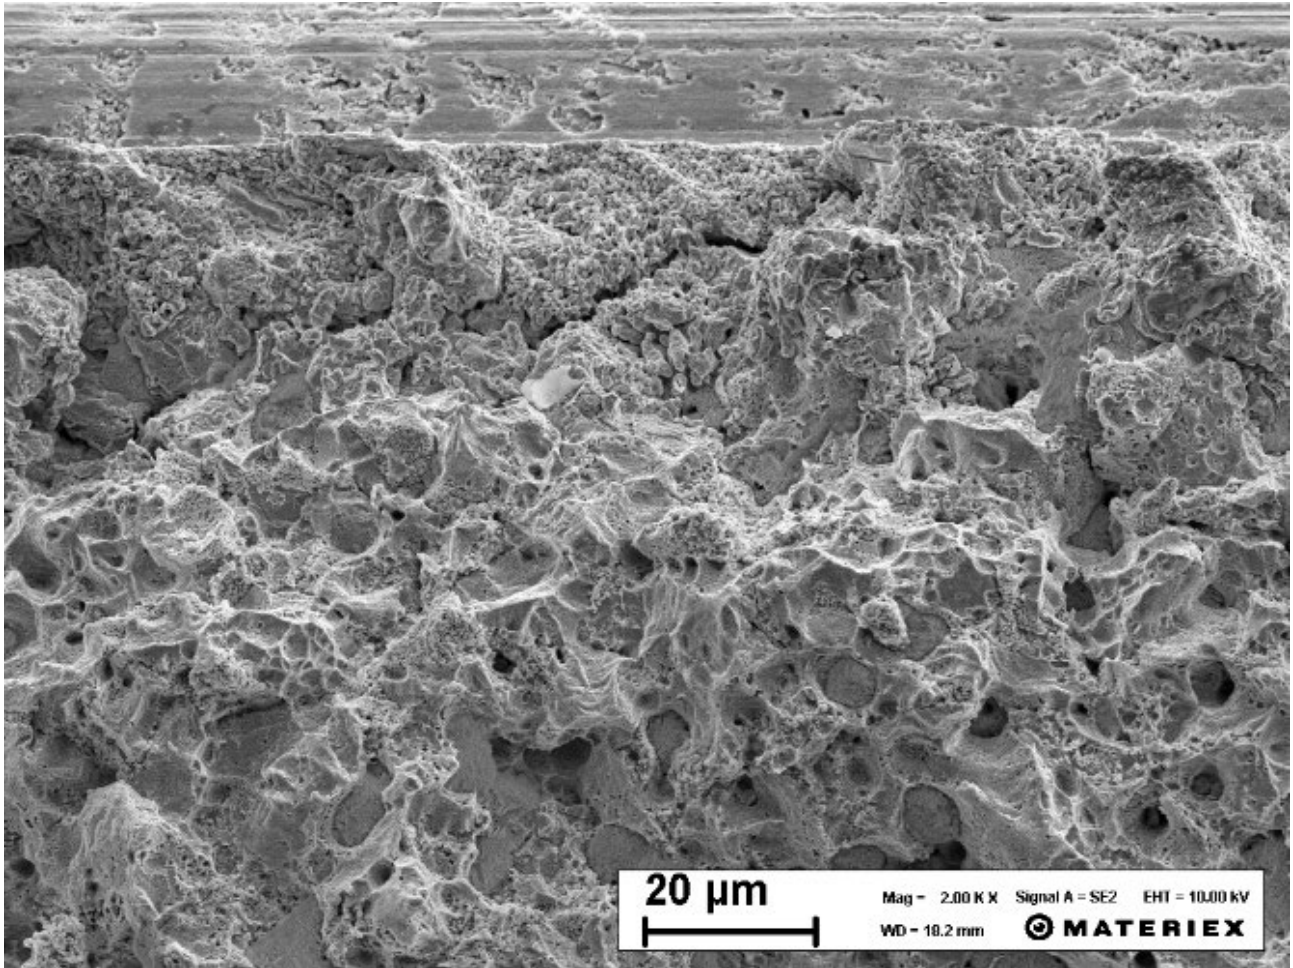
Figure 3. Overload fracture at the crack tip of the leaking fitting (SEM).
