***MATERIEX CASE STUDY***  
**STEAM TURBINE FAILURE**

Two low pressure (LP) steam turbine rotor blade ruptures were discovered during an inspection that was carried out due to high vibrations during start-ups. The two ruptured blades had both been mounted in row 19, the 1<sup>st</sup> row in the LP stage. The fractured blade roots were cut out and sent to Materiex AB for failure investigation.

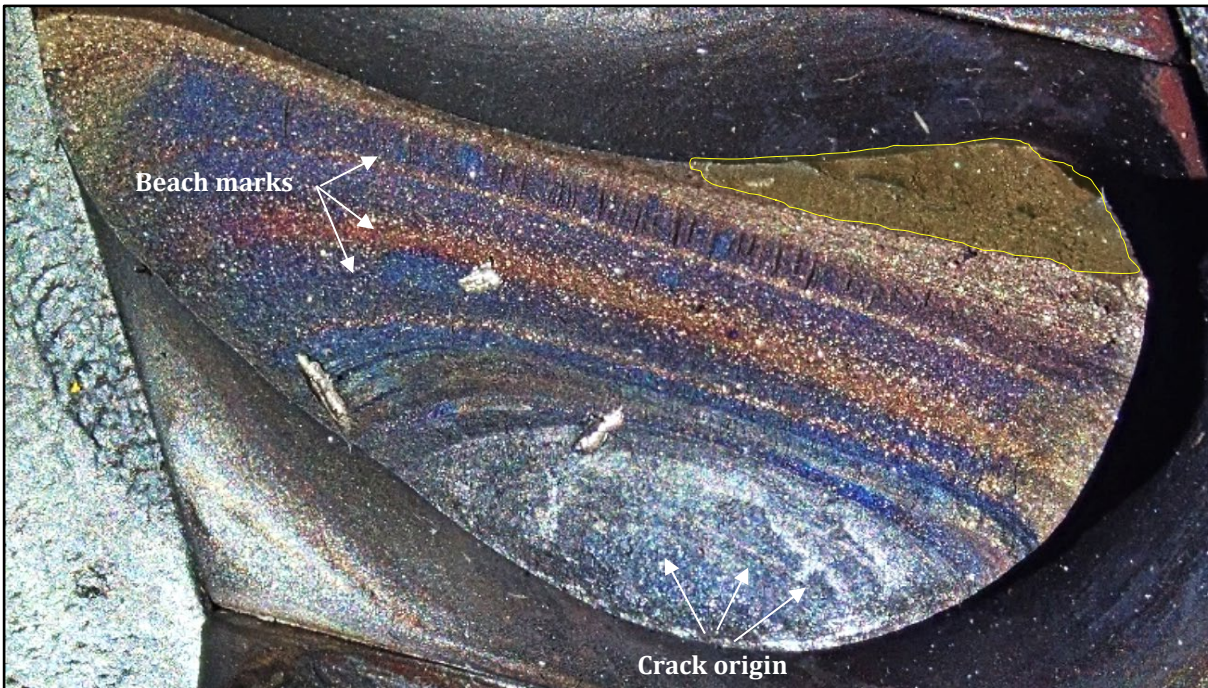
- Chemical composition and hardness measurements showed that the rotor blade material conformed with the specifications (Table 1-Table 2).
- The macroscopic appearance with beach marks visible on the fracture surfaces indicates that the blade fractures have been caused by fatigue, initiated at the suction side of the blade roots. Beach marks are macroscopic concentric rings that represent sudden changes in load and/or environmental conditions.

- The total number of beach marks was estimated to be 30-50 which may be interpreted to equal the number of starts/stops needed to cause the fracture. The different colours of the beach marks indicate various degrees of oxidation which may be referred to as different stages under which the fatigue crack has propagated.

**Figure 1.** Fracture surface of the blade root, shows a large number of beach marks.

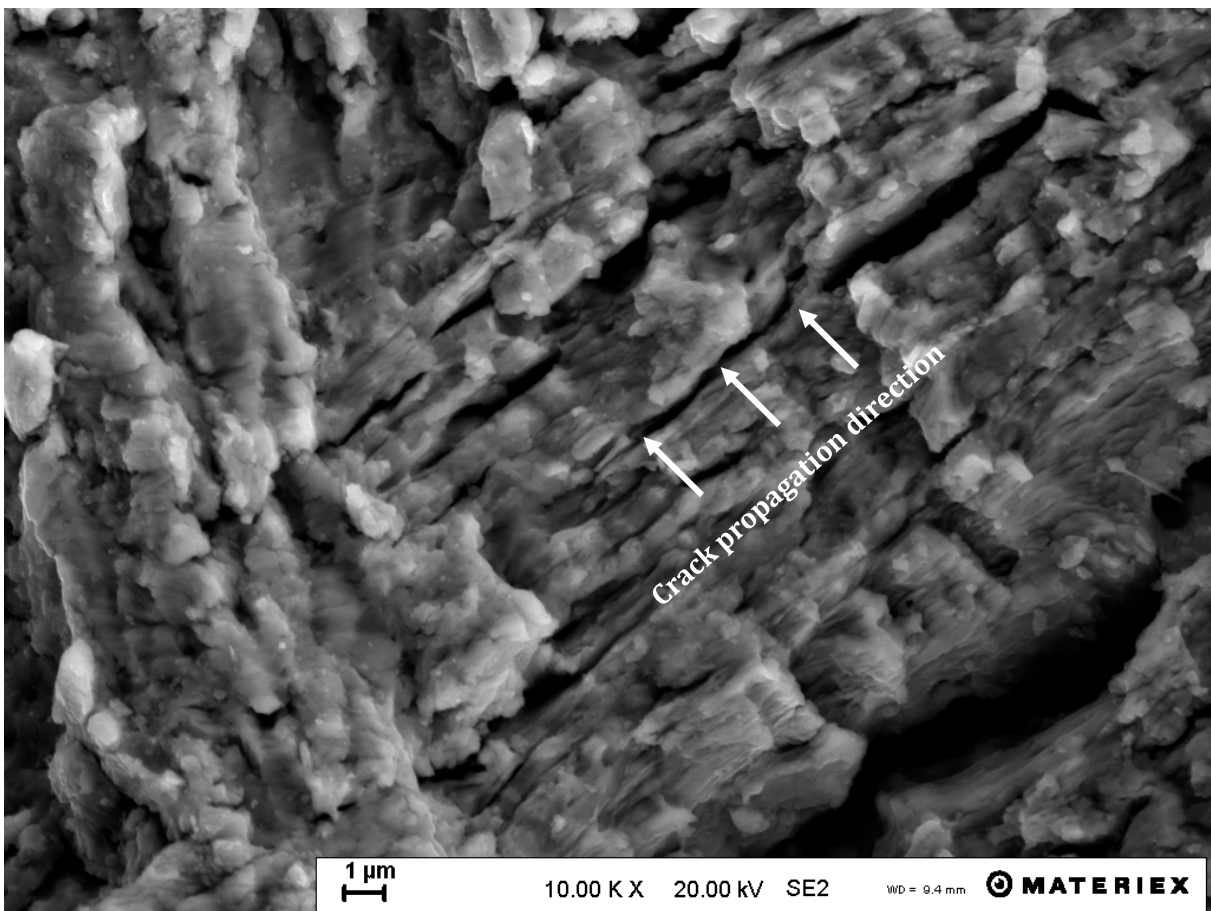
- A detailed study of the fracture surface in SEM showed the presence of so-called striations (Figure 4). Striations are microscopic parallel lines associated with fatigue failures and where each line represents the crack front during one load cycle.

**Figure 2.** SEM-image showing fatigue striations visible at high magnification. Arrows indicate crack propagation direction.
