***MATERIEX CASE STUDY***  
**STEAM TURBINE FAILURE**

Two low pressure (LP) steam turbine rotor blade ruptures were discovered during an inspection that was carried out due to high vibrations during start-ups. The two ruptured blades had both been mounted in row 19, the 1<sup>st</sup> row in the LP stage. The fractured blade roots were cut out and sent to Materiex AB for failure investigation.

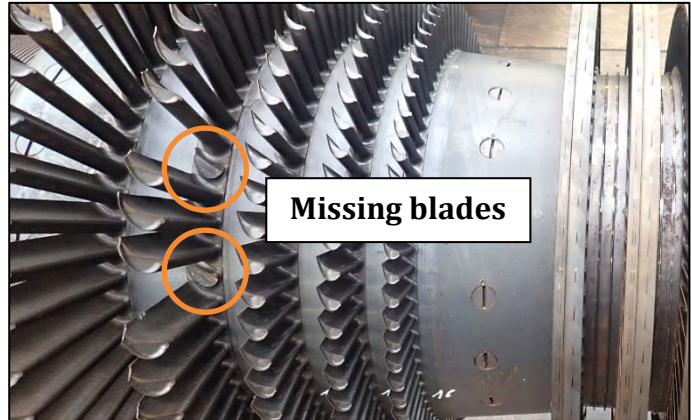
- Chemical composition and hardness measurements showed that the rotor blade material conformed with the specifications (Table 1-Table 2).
- The macroscopic appearance with beach marks visible on the fracture surfaces indicates that the blade fractures have been caused by fatigue, initiated at the suction side of the blade roots. Beach marks are macroscopic concentric rings that represent sudden changes in load and/or environmental conditions.

- The total number of beach marks was estimated to be 30-50 which may be interpreted to equal the number of starts/stops needed to cause the fracture. The different colours of the beach marks indicate various degrees of oxidation which may be referred to as different stages under which the fatigue crack has propagated.

**Figure 1.** Fracture surface of the blade root, shows a large number of beach marks.
